UCRSP  
10-11-1-6  
Vol. 8.1  
1/14/11

Field Trip Report of  
**Adrian Brown, PE**  
Pakootas et al v.  
Teck-Cominco Metals Ltd

Date: January 14, 2011

Project No. 1615A

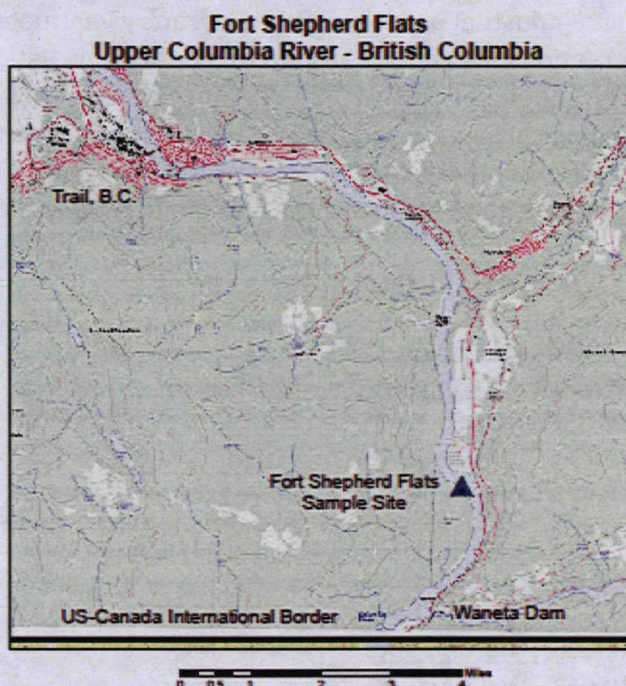
Figure E1. Fort Shepherd site at Columbia River Mile 748.

Conducted over two separate trips from September through November of 2009, the objective of the study was to observe flow regimes and depositional environments between Trail and the US border. A sample of coarse-grained, slag-enriched sediment from Fort Shepherd (river mile 748) was collected. This sample was delivered to Hazen for magnetic separation, sieve analysis, chemical assay, and [QEMScan](#) analysis.

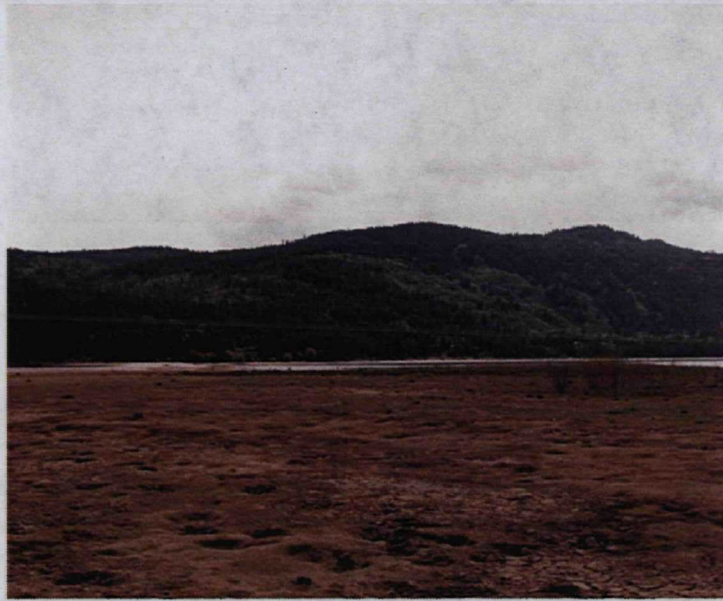
Figure E6. Vegetated sediment bar near Evans, river mile 712.

At NPE, Lake Roosevelt officially reaches Dalles Orchard Beach (RM 729), 6 miles south of Northport. The lake effect pushes an additional 14 miles upstream. The lake transition is marked by reduced current velocity and the submersion of historic river banks. River banks and benches stretch up to 100 yards wide from NPE shoreline to the channel itself. Relative submergence period is indicated by the thickness of vegetation on high points. During field operations in April and May of 2010, pool elevations at Coulee dam were between 1264 and 1270 feet, shifting the lower end of the lake transition zone to Bossburg (RM 716) and the upper end of the lake transition zone to the orchard off the south end of Northport (RM 734).

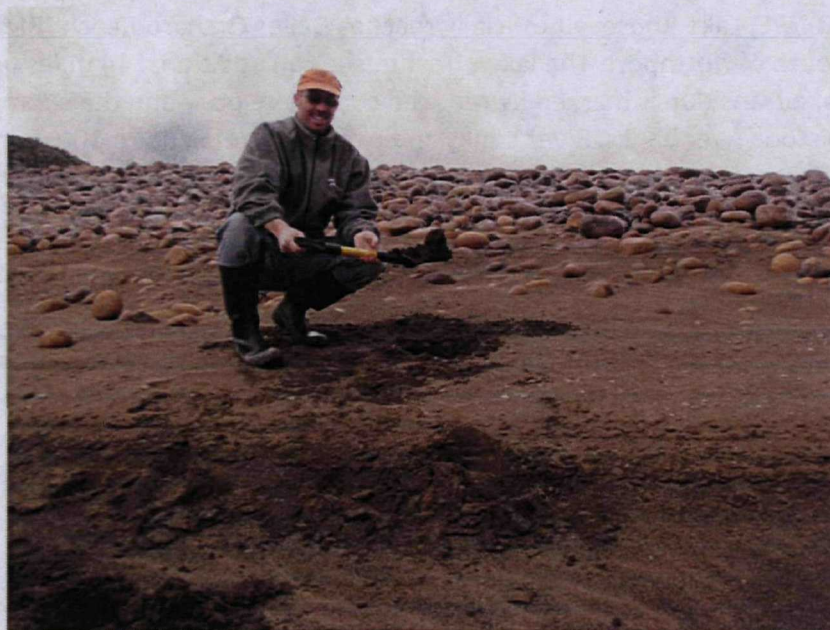
Figure E7. Cobbles over sand at the Northport bar, river mile 734.

Sediment bars in the upper Columbia can be categorized as either coarse or fine. Coarse sediment bars occur between Trail and river mile 732 just south of Northport. These bars are comprised of gravels, cobbles and boulders up to 12 inches in diameter. From Northport down to Marcus and Summer Islands, bars tend to be medium sand to silt, with occasional pebbles on the upstream tails. Below Marcus Flats, no bars were exposed during site visits. Shallow benches at Colville Flats and Frenchman Point Rocks cored fine sand to clay with rounded pebble clasts in the lower core sections. Between Mission Point (RM 678) and Inchelium (RM 675), benches averaged 60 foot depths and cored silt to clay.

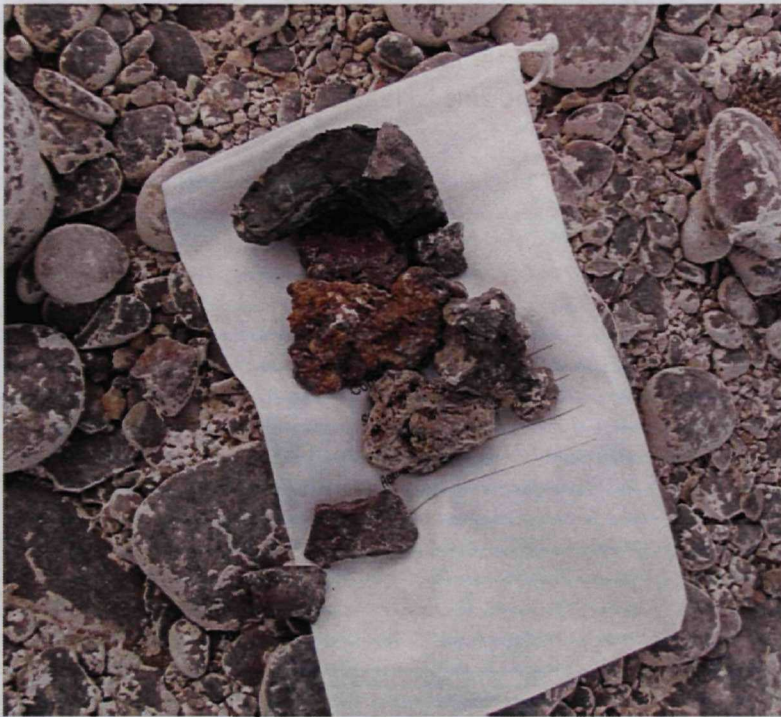
Figure E8. Coarse slags at Northport.

Metallurgical slag was observed from Trail to Marcus Flats in channel and bank deposits. Between Trail and Northport, slag particles mix uniformly with coarse sand depositing on riverbanks, in river eddies, and between boulders in the channel. At Northport, extensive deposits of slag ranging from medium sand to ½ inch flakes to 8 inch cobbles were observed along the waterfront from the smelter site down to the Highway 25 Bridge. Below the bridge, slag particles ranging from medium sand to ½ inch flakes to ¾ inch pebbles were observed fining with distance from the smelter site. The lowest observed deposit of riverbank slag was at Dalles Orchard Beach (RM 729). Slag particles were predominately coarse sands mixed uniformly with beach sands. Lesser amounts of ⅛ inch flakes were noted concentrating in a band at waterline by flotation from the sand matrix. Between Dalles Orchard Beach and Marcus Island (RM 709), macroscopic slag was not observed in riverbank or sediment bar deposits, or shallow sediment cores. Channel cores were not collected above Marcus Flats due to the mechanical inability to recover particles cobble size or larger. A channel core recovered in Marcus Flats (RM 707) contained >75% slag in the medium to coarse sand particle range.

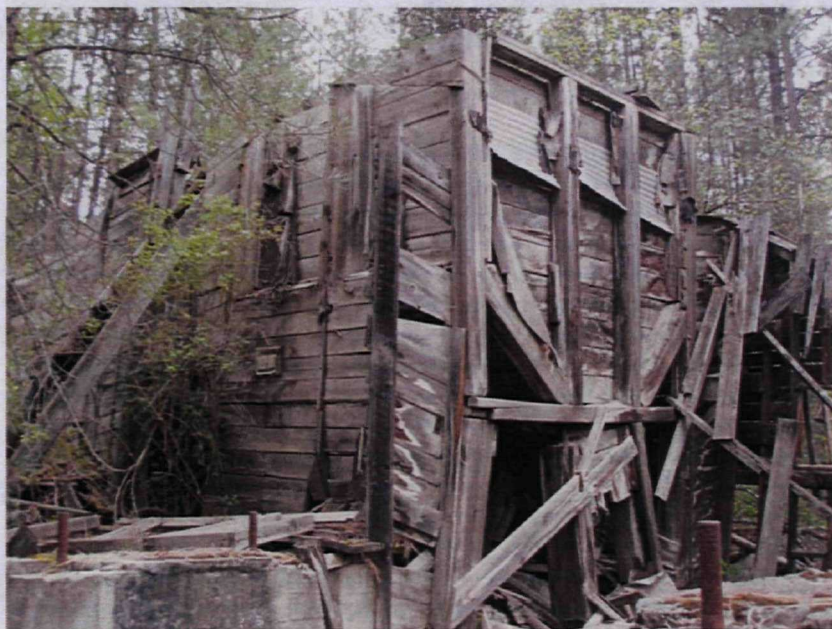
Figure E9. Gregor Mill at Bossburg, river mile 716.

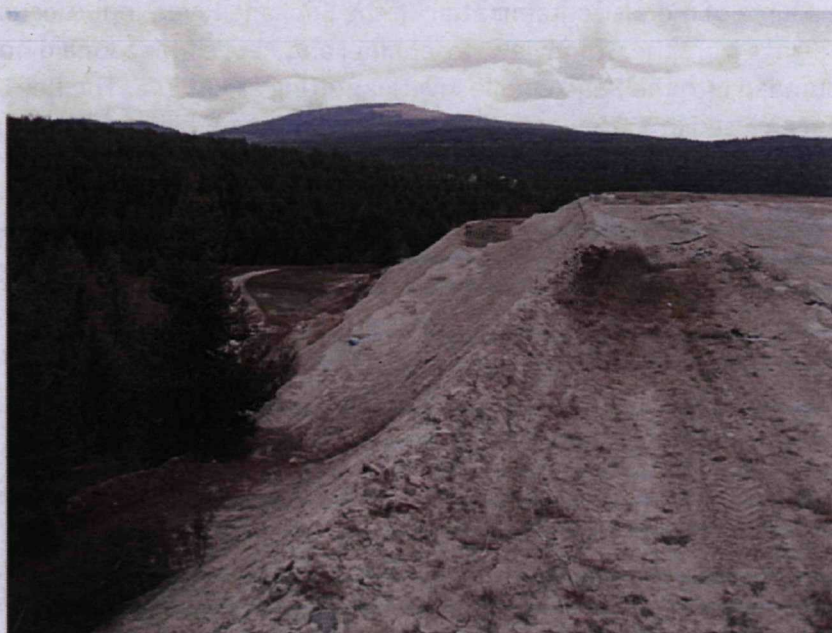
Figure E10. South high wall of the lower Van Stone tailings impoundment.

The Van Stone silver-lead-zinc mine is the largest in eastern Washington and a source of historic contamination from mining and milling operations, including a 1952 Onion Creek fish kill traced to the accidental release of liquid effluent. Shuttered in the late 1990's, the open pits and tailings disposal facilities are maintained in accordance with the closure plan under the direction of Beacon Hill. On a site visit May 7<sup>th</sup>, it was observed that runoff from the outer walls carried fine grained tailings material onto the road and into the Onion Creek watershed. Samples of tailings submitted to ACT labs assayed 811-1830 µg/g Pb and 3570-5860 µg/g Zn. The EPA collected five samples near the Van Stone for the 2001 ESI study. The stream sediment samples returned metal values near background, but it should be noted that all of the sample sites were upstream of the mine, mill, and tailings piles. Under the 2001 Mines and Mills study two samples were collected, one upstream of the upper tailings pile, and one adjacent to the lower tailings pile. Lead and zinc values were consistent with background and tailings, respectively.

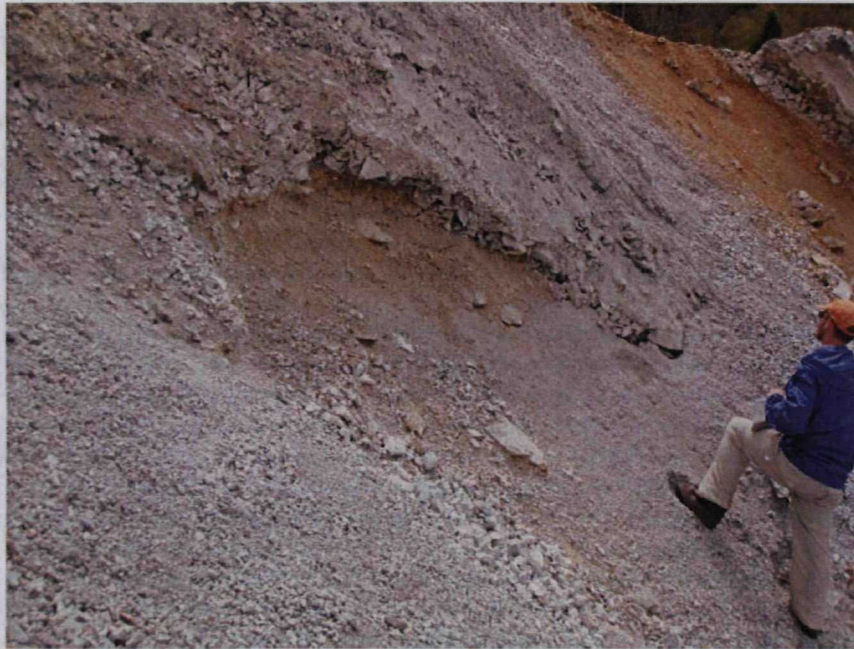
Figure E11. Tailings pile at the Black Rock mine on Northport-Aladdin Road.

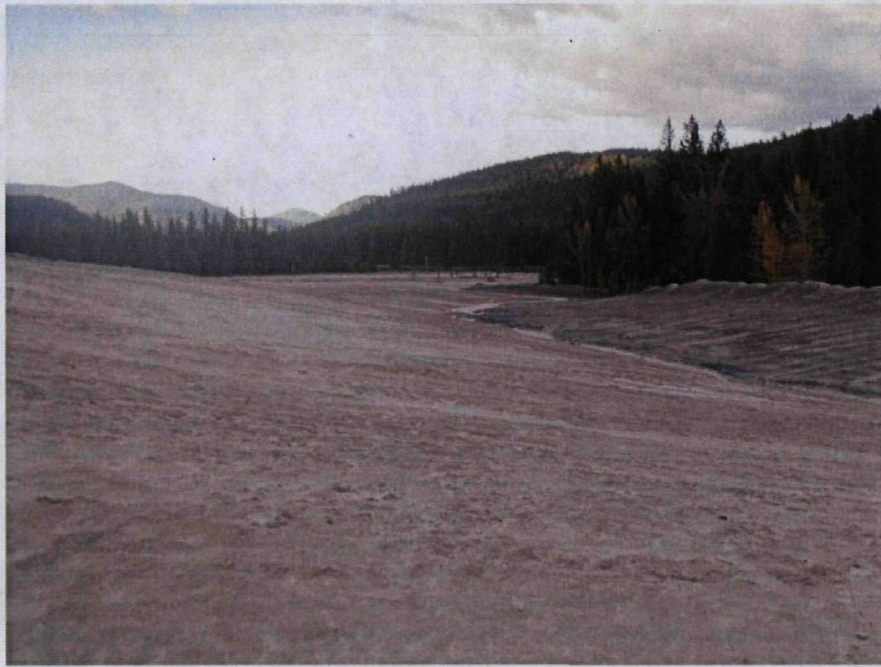
Figure E13. Sierra Zinc tailings discharge area, south fork of Deep Creek.

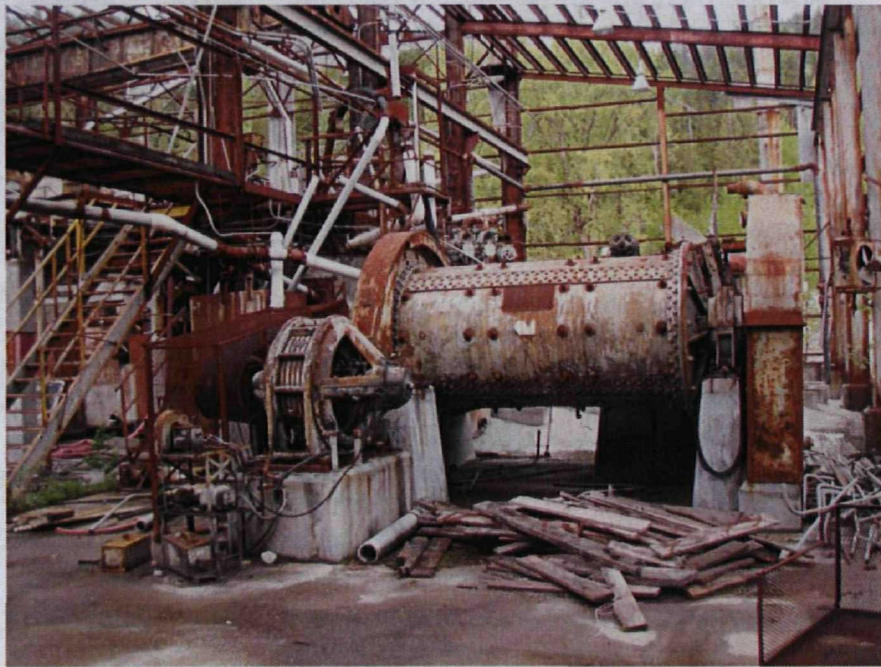
Figure E14. Anderson-Calhoun Mill, north fork of Deep Creek.

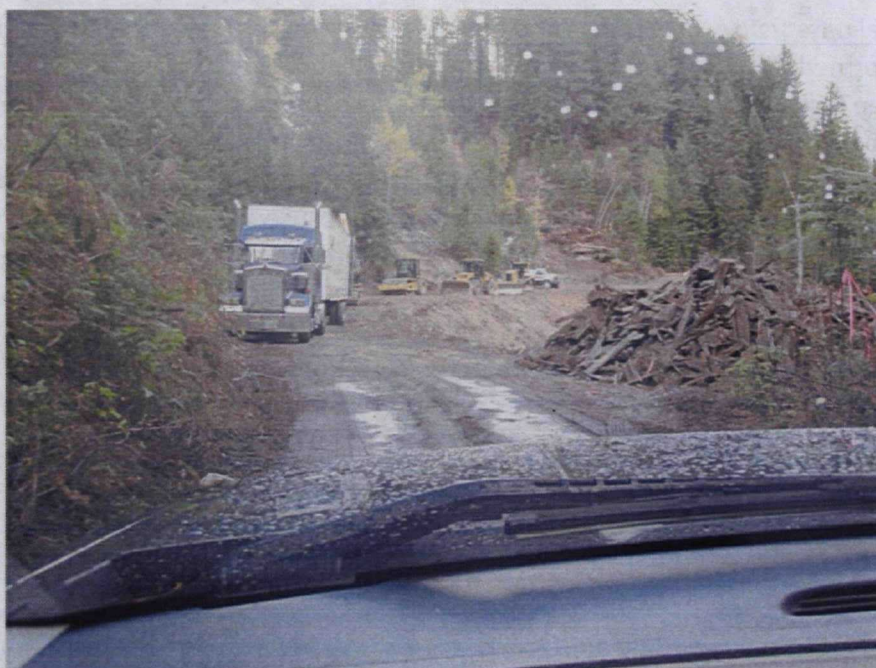
Figure E15. CERCLA remediation at the Josephine #1 Mill, Metaline Falls.

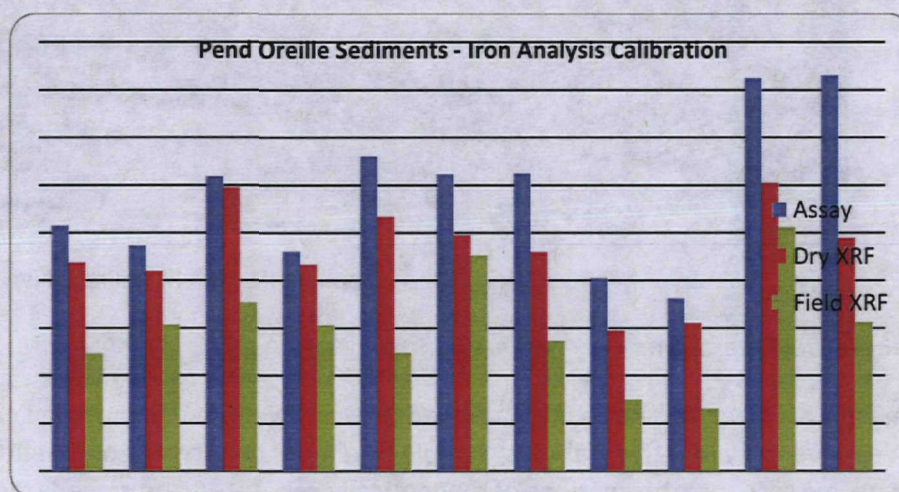
Figure E16. XRF calibration plot for iron.

To validate field XRF readings and ensure proper sample selection, XRF analysis was performed by Greg Diefenbach on samples selected for chemical analysis. The samples, under Tasks 3.2-3.5 and 4.1-4.3 plus the *General Interest* category, were dried in a nitrogen purged oven and magnetically separated and sieved in accordance with the Hazen Project 11177 Procedures. XRF calibrations confirmed that field results for iron, lead, manganese, and zinc were consistent and conservative, reporting 40% - 70% of the assay value. Readings for other metals were unreliable. XRF analysis of the dried samples returned values in between the field values and assay values. All samples except tailings collected directly at the Anderson-Calhoun and Sheep Creek mills returned XRF zinc values greater than the rejection value of 600 ppm. See Appendix E3 for field XRF data calibration.
